INVESTIGATION REPORT

HOTEL FIRE  
GREECE, NEW YORK  
TEN FATALITIES  
NOVEMBER 26, 1978

DAVID P. DEMERS  
FIRE ANALYSIS SPECIALIST  
FIRE INVESTIGATIONS DEPARTMENT

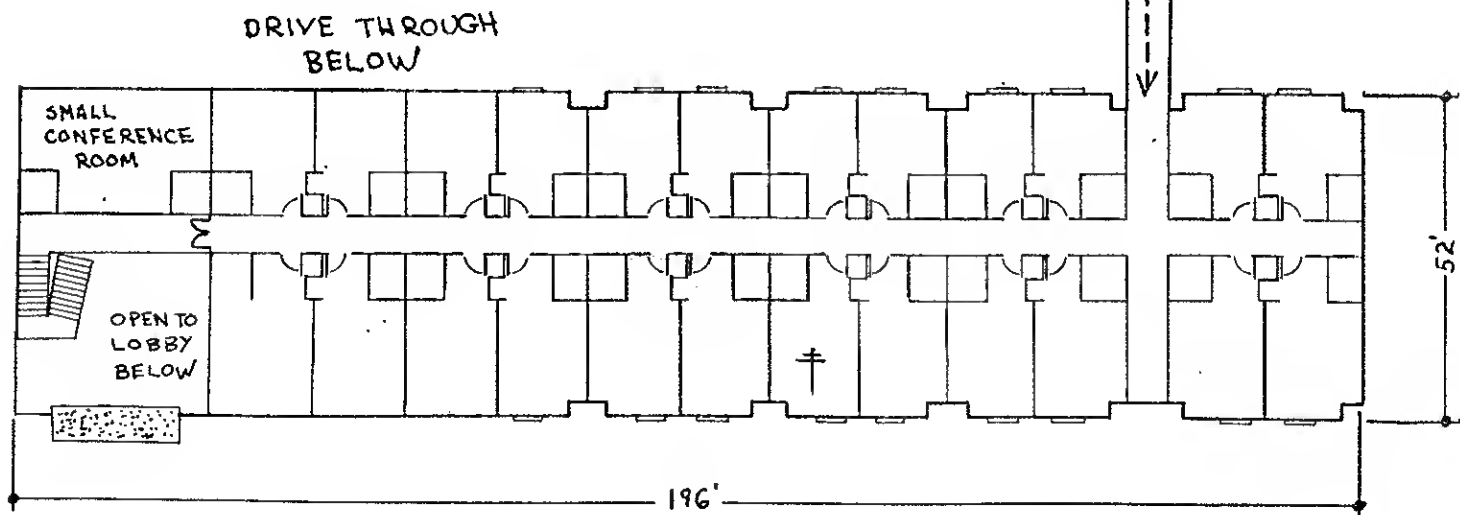
† FATALITIES, 2 WERE DOA  
AND CAME FROM UNKNOWN  
LOCATIONS  
10 FATALITIES TOTAL

--> INITIAL FIRE SPREAD  
OUT OF CENTRAL STAIRWAY
